Report No. FHWA - KS - 98/2  
CONSTRUCTION REPORT

# HIGH PERFORMANCE CONCRETE PAVEMENT

**K-96, Reno County, Kansas**  
**96-87 K 4457-01**

**Construction Report**

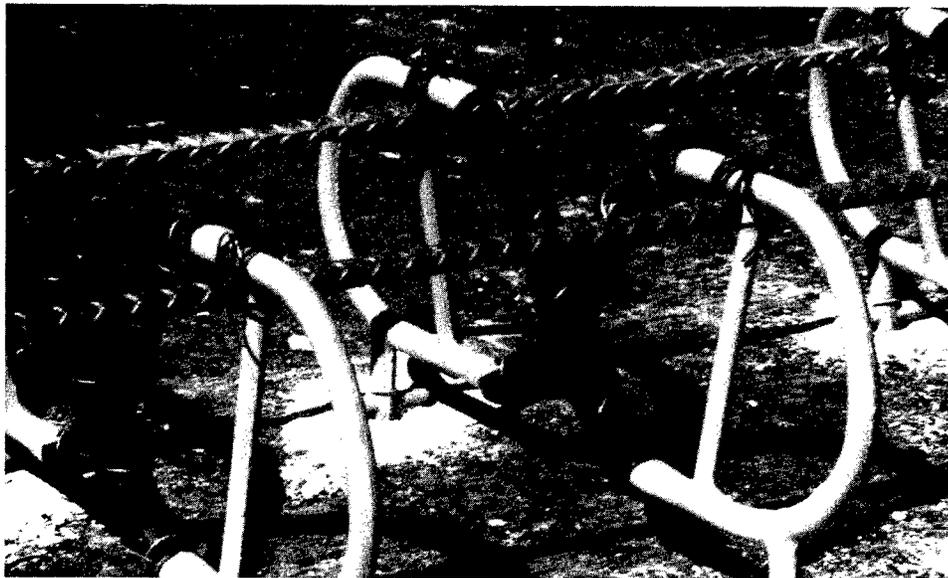
**X - FLEX™ Load Transfer Devices**  
**Figure 2**

**4., 5. & 6. Alternate Saws and 3M Fibers** - Three different brands of saws were tried, and shallow depths of cut were made at an early age with the soft-cut saw. A special 152.4 m (500') test section incorporating 3M polyolefin fibers [1.57 mm (0.062 in.) diameter] was placed at the west end of this one kilometer test section. In addition, five joints had a special "X-FLEX™" load transfer device (Figure 2), developed at Kansas State University, instead of the dowel bars. These were designed to transfer the load by tension in the "x" rather than by shear.

**X-Flex™** load transfer devices were also tested under static and fatigue loading in laboratory size specimens and found to be stronger than conventional dowels at transferring the shear load across the joint. The “X” of the patented device, cushioned with a rubber tubing for this project, goes through the joint with the far ends curving around in a loop that make a continuous configuration. The device is made from 13 mm (0.5 in.) steel cast bars and epoxy coated. These devices were spaced at 305 mm (12 in.) centers in the pavement.

In this one kilometer test section two other special features were tried in short sections. The first one consisted of X-FLEX™ load transfer devices [at five 7.3 m (24 ft.) joints] of a special “x” design that transfers the shear forces by tension. When placed, these were only about 38mm (1 1/2 in.) below the surface and four of the ten lane width units were struck and dislodged by the paving machine. Regular dowels were then placed in three of these four joints and hand finished.
